INSTITUTIONAL WATER TREATMENT

By Mohammed Abdul Rahman, Sahara Industry

Case Study: Water Filtration Plant at Le-Meridien Hotel, Hyderabad

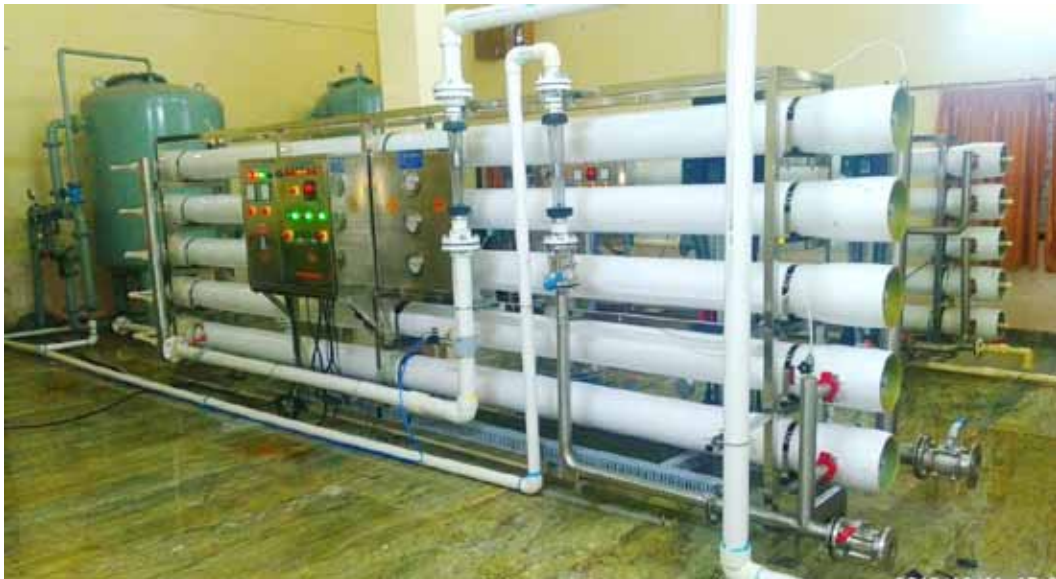
50 M³ hr Reverse Osmosis Plant Installed in Logistic Park, Hyderabad

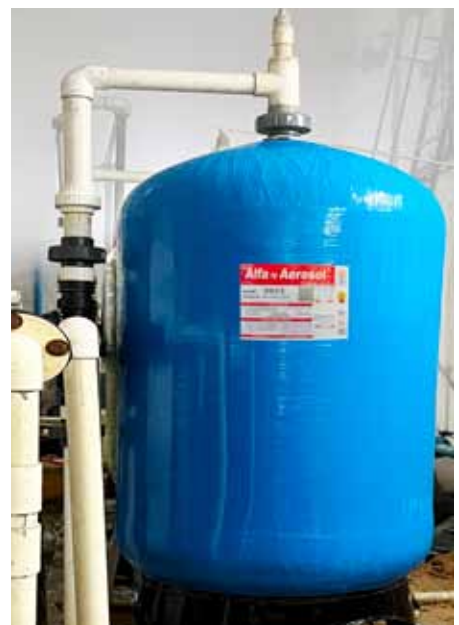
3672 FRP Pressure Vessel for Industrial RO Water Purification System installed in Le-Meridien

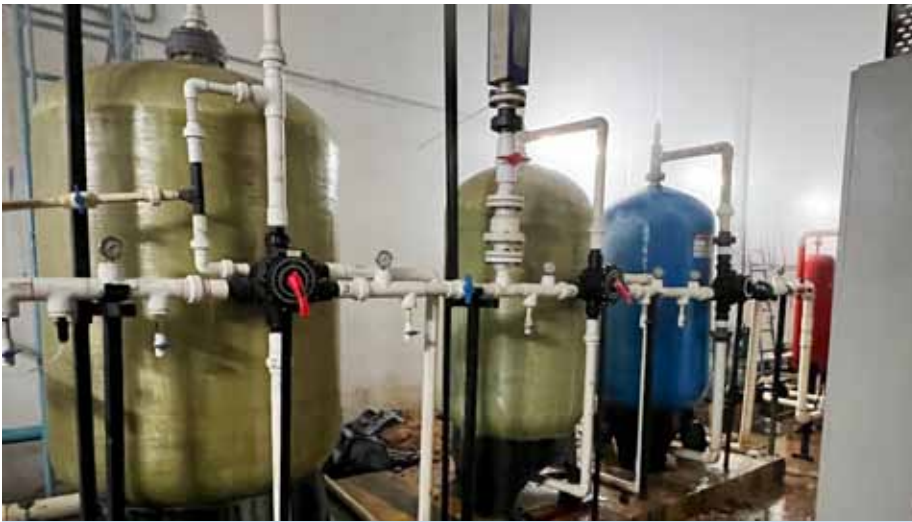
Pic 1.1-Existing Sand Filter System at Le-Meridien

In this case the water was not being passed by the sand filter because of the inattention of the people responsible for maintaining it and not backwashing the sand filter as required.

water. On the bottom layer the large size pebbles are layered so that the water can pass through without any hurdle. But the existing sand filter had only 10-20 mm size of pebbles present in it and as a result the required amount of water was not passing through it.

- ❖ The sand and pebbles inside the sand filter vessel was completely converted into big rock which was impossible to take out from the vessel. As you can see in the image (Pic 1.1) only the suspended solids which were stopped by media from the flowing water can be seen and rest of the media has been crushed and altered to become the rocks.

- ❖ The media of the sand filter converted itself into a solid rock as the required backwashing of the sand filter was not done and it continued to be used in filter mode for over a year without considering the maintenance of media and cleaning it. With consistent use and rocks getting bigger and bigger with the accumulation and even after it was blocked completely then the sand filter was running in bypass mode.

- ❖ The distribution system or strainer through which the raw water has to pass was also completely blocked with suspended solids due to continuously running the sand filter without backwashing it.

To make the water treatment plant functional again, a new vessel and sand filter was installed. The process of re-establishing of the filter plant included several remedial and retrofitting exercises, such as:

- ❖ The existing sand filter was cut down, jack hammered and pulled out of the space where it had existed to make way for the new one to be installed making the water treatment system functional again.
- ❖ The lower and upper pipes and fittings of the multi-port valve were carefully removed without dismantling the entire set so that the pipeline remains the same as it was before.

- ❖ A new FRP Vessel of Alfa Aerosol of the same size 3672 has been installed with the same diameter of pipeline.
- ❖ The media with multiple size pebbles, quartz and fine sand has been used to fill the sand filter vessel.

- ❖ A new distribution system has been installed at the bottom of the vessel so that the water can freely pass through it.
- ❖ The filter has been open backwashed before fitting inside and then programmed to be running in filter mode after fixing all the pipelines and making it functional.

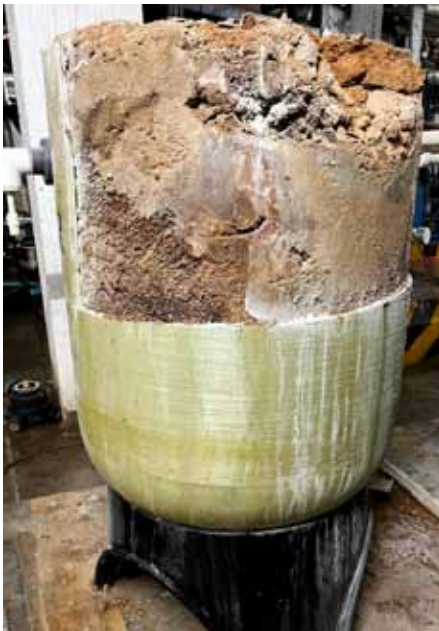
Pic 1.2-Cut Open Sand Filter Vessel at Le-Meridien

The engineers deployed by the Sahara Industry inspected the filtration plant and concluded that the filter media has completely stopped functioning. The solution was not simple due to massive issues and needed extra-ordinary solutions. The team working on the site was not able to extract the filter media from its designated place and had to cut open the vessel from outside so that the media present inside of the vessel could be taken. But the contamination of water got the media jammed and so stiff that even

after cutting the vessel, it was not able to be taken out of the vessel, as you can see in the image (Pic 1.2). The giant rock that formed inside the vessel had to be broken into pieces using the high capacity jackhammer machine but in the process, the vessel was completely destroyed.
